Swissair 111 Reconsidered

By William Henry
December 5, 2007

William Henry returns with an important perspective on the Swissair 111 tragedy. Henry Argues that numerous factors such as electromagnetic interference and defective wiring contributed to this tragedy in a more significant way than are currently accepted.

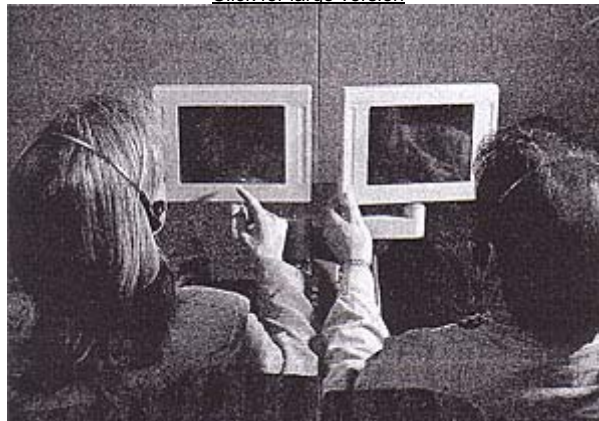
Furthermore, HB-IWF was one of 16 Swissair MD-11s equipped with an interactive in-flight entertainment network (IFEN) manufactured by Interactive Flight Technologies (IFT) that provided travelers with on-demand videos, music, games, and gambling.⁷ Since the Flight 111 tragedy, it was discovered that the IFT system would operate at 10-20°C hotter in an airplane, and was never tested at such temperatures. Also, the installation of the IFT system was deplorable; the installers

"mixed wire types, installed wires under metal clamps not designed to hold wire, ... installed coaxial cables with right angles," and connected the system "to the wrong electrical power source."⁸ Santa Barbara Aerospace (SBA) was contracted to certify the IFT system, and used myriad dubious techniques to do so, including utilizing false statements, misleading proposals, and incomplete paperwork. A supplemental type certificate (STC ST00236LA-D) was issued before the system was even installed or functional. Although the STC ensures that the aircraft passes electromagnetic interference tests mandated by the FAA, the IFT system was not tested for susceptibility to High-Intensity Radiated Fields (HIRF) after the installation was completed.⁹

Interactive Flight Technologies Entertainment System
© Aviation Week & Space Technology

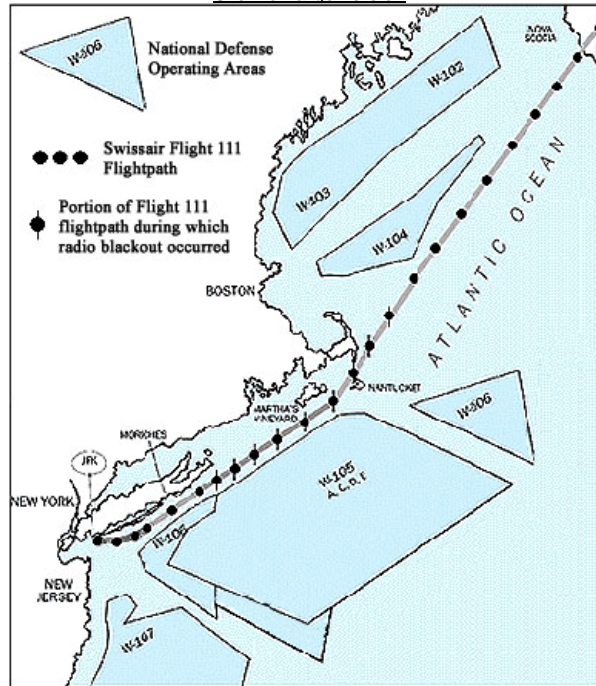
On September 2, the day of the Swissair Flight 111 crash, seven electromagnetically active craft (the USS Connecticut, USS Dallas, USS Billfish, two P-3 Orions from Patrol Squadron 26, a P-3 Orion from Patrol Squadron 10, and a KC-135 air-to-air refueling aircraft from McGuire Air Force Base), as well as "other aircraft of unknown type and origin" were present in both the restricted area bordering the non-military corridor through which Swissair Flight 111 traveled, and the commercial aviation passageway.¹² The P-3 from Patrol Squadron 10 was equipped with high-powered electromagnetic transmitters, similar to those used by electronic warfare aircraft. Because of the advanced technology aboard this particular P-3, other aircraft flying in its proximity would probably experience significant electromagnetic interference. In fact, during the afternoon of September 2, a P-3 from Patrol Squadron 26 was forced to land early because one of the P-3s from Patrol Squadron 10 was present in the same corridor, which spanned hundreds of square miles.¹³ It seems incredible that not only were three of these aircraft present in the same corridor, but also that the corridor within which they flew was situated next to a commercial aviation passageway. It was through this passageway that Swissair Flight 111 would travel.

Schematic Chart of the Flight Path of Swissair 111
© Elaine Scarry/AirmanshipOnline

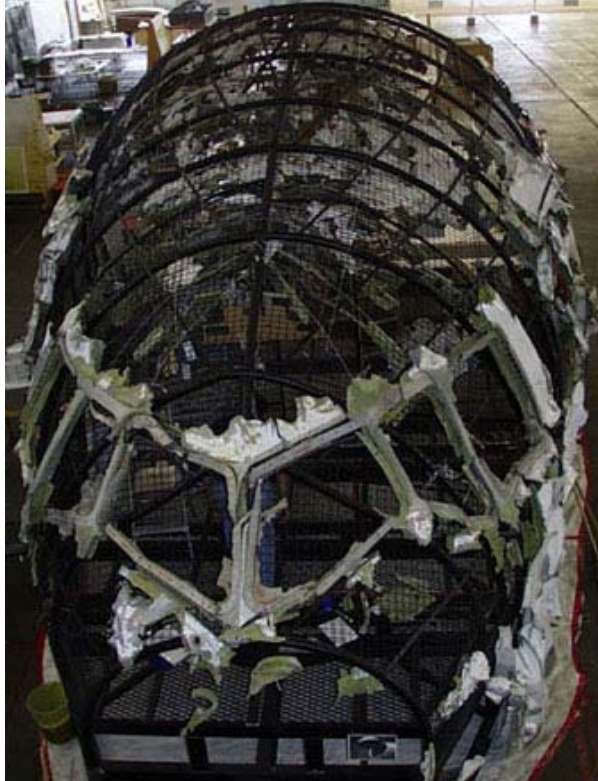
In an effort to determine the cause of the accident, the TSB embarked upon the enormous task of recovering and analyzing as much of the aircraft as possible. The plane was destroyed to such an extent that an entire hanger had to be constructed simply to house the countless aircraft fragments. Because the smoke was initially reported in the cockpit, the TSB decided to reconstruct as much of the fore-section of the aircraft as possible. Although these extensive efforts were able to prove where the fire started and how it was propagated, they fell short of proving why it initially broke out.²² The conclusion of the TSB was that "within the localized area where the fire most likely started, a wire arcing event is the only plausible ignition source. ... [The TSB found 17] cable and wire segments with arcing damage, ... eight [of which] ... were from the IFEN installation."²³

The Reconstruction Mock-Up
© Transportation Safety Board of Canada

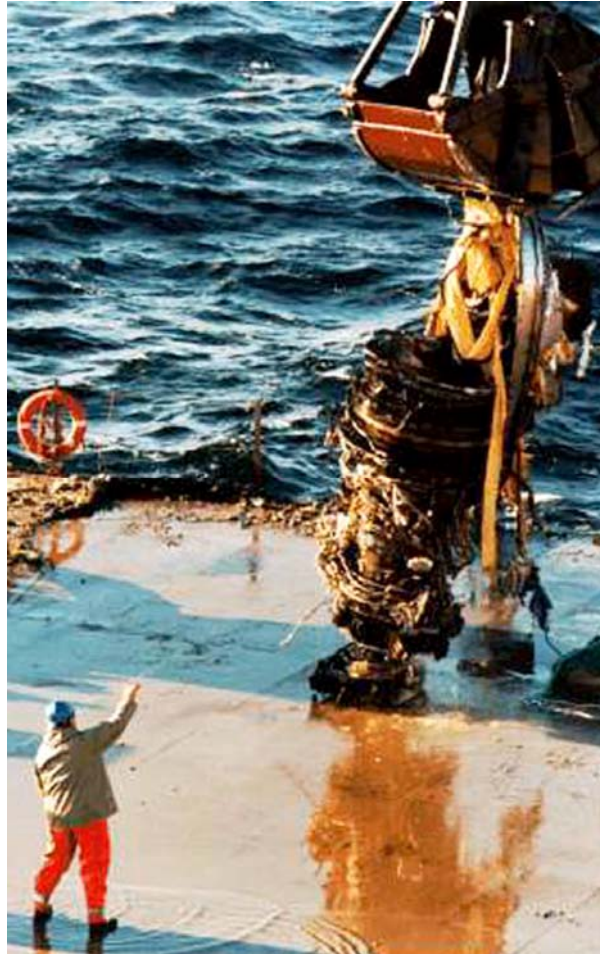
Engine Number 3 Being Lowered on to the Deck of a Barge
